Service Bulletin; Oct, 10, 05.

Aircraft Affected; Moose, Super Rebel

Area; Outboard end of the aileron torque tube in the wing.

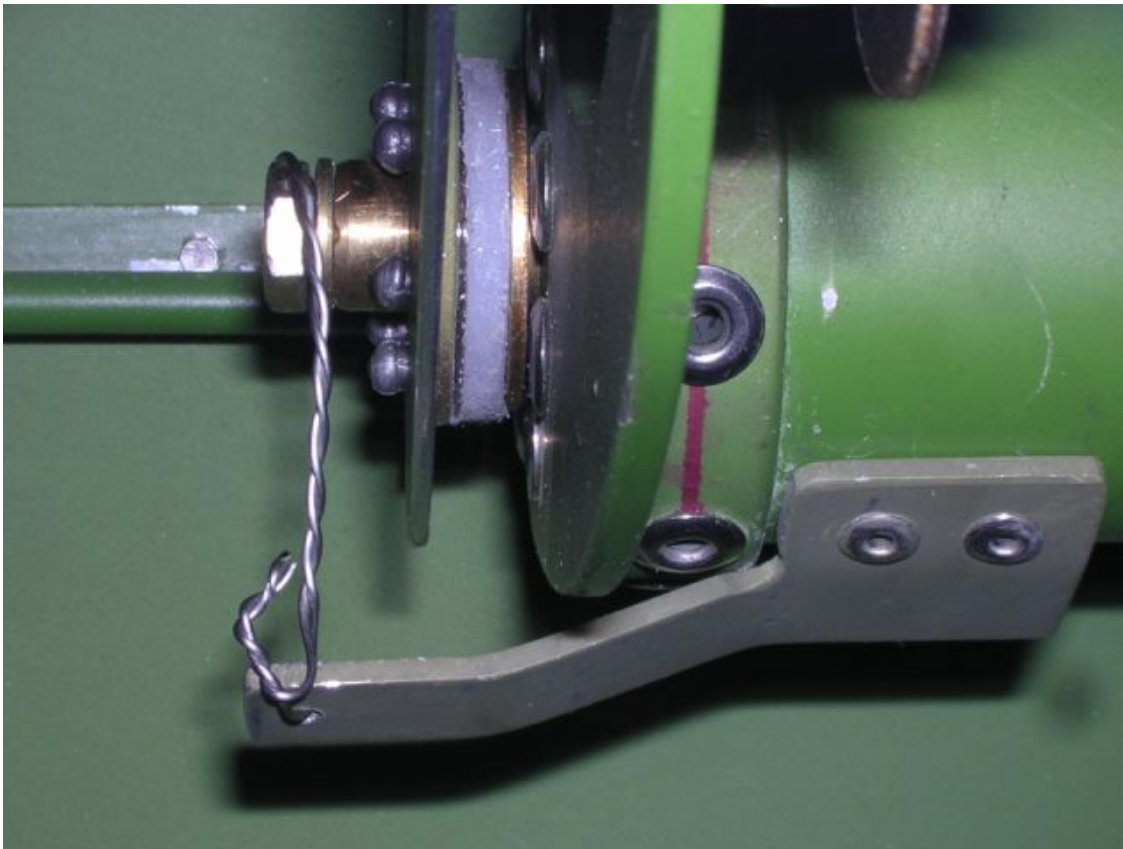
It has been brought to our attention that the AN4-13A bolt that serves to attach the aileron torque tube to the torque tube attach bracket, W0542, should be a drilled head

Bolt, AN4H-13A and the head should be safety wired, see attached photo.

There are no known cases of this bolt loosening and the chance is remote as two separate bearing points would have to seize for this bolt to start to turn as well as overcome the locking feature of the anchor nut.

However it is a rotating surface and therefore should be safety wired.

All the brass and steel bushings must be lubricated with a mild lubricant such as white lithium or LPS2.
