Wing Tip Service Bulletin

Re: Wing tip rib/rear spar

3500 WING TIP MOD

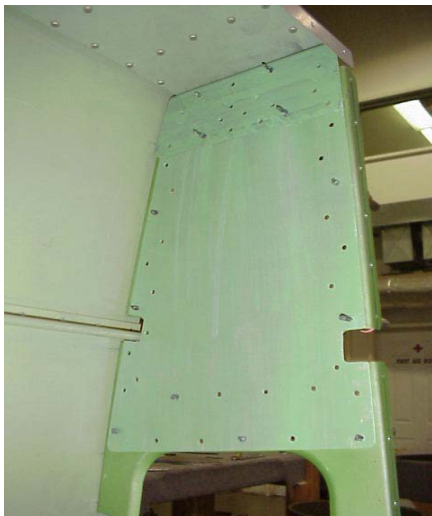
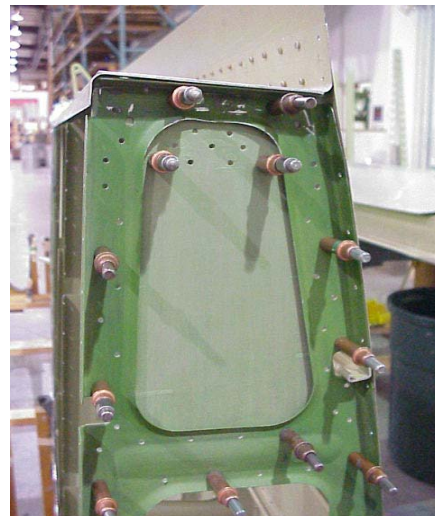
3/ Trim the ALUMINUM DOUBLER to fit one eighth of an inch inside the radius of the rib flanges to prevent cracking along the flanges. Make sure you cut out the stringer slots and LATER you will trim the trailing edge for the STEEL DOUBLER fitting. The ALUMINUM DOUBLER must be fit on the flat side of the rib because everything sits flat this way. [this means that on your left wing the mod will be on the outside and on the right wing it will be on the inside!]

4/ Once the ALUMINUM DOUBLER is trimmed layout a rivet pattern similar to the drawings provided. **IMPORTANT:** as you can see from the photos the STEEL DOUBLER is incorporated with the ALUMINUM DOUBLER so you must be very careful when laying the rivet pattern out. The rivets used in this mod are a one eighth rivet so you need a quarter of an inch edge distance for EVERYTHING! Start by drilling #40's and leave it at that for now.

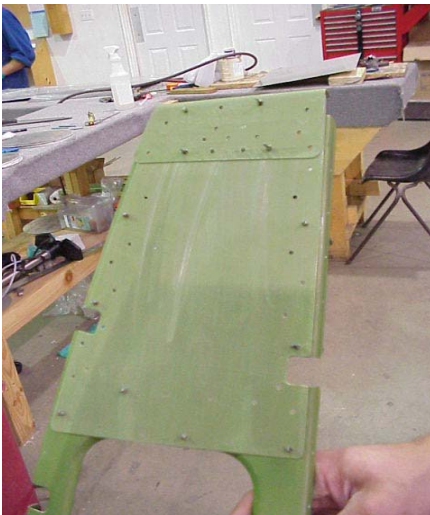
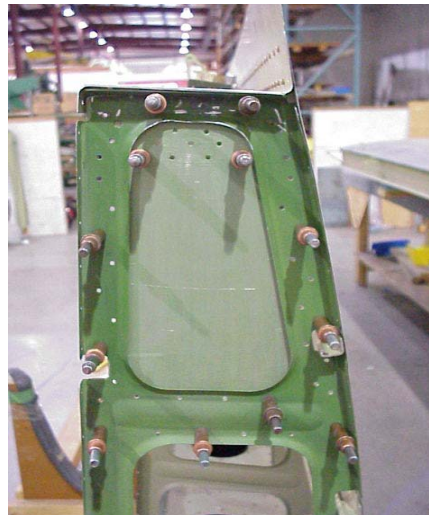
5/ Now pick up the STEEL DOUBLER and trim it to fit as the new rib flange. Trim it so it stays clear of the rear spar radiuses but if you trim too much you will have no edge distance for your hinge bracket bolts! Cleco the skin [top and bottom] back onto the tip rib to ensure great alignment. Next fit the STEEL DOUBLER to the ALUMINUM DOUBLER making sure the new rib flange has a perfect fit to the rear spar and finish drilling to #40. You can now drill all doubler holes to #30. With everything still clecoed in place drill into the new steel flange in between the hinge bracket holes at #40 to create pilot holes to simplify drilling the steel. Cleco each hole as you go. Drill the hinge bracket holes next to #40 and when all holes are drilled finish the hinge bracket with #11 holes and the holes in between are #30.

6/ Take both doublers off and deburr. **TO PREVENT CORROSION PROBLEMS YOU MUST ZINC CHROMATE BOTH DOUBLER PIECES AS WELL AS DIP EACH RIVET IN CHROMATE BEFORE INSTALLATION!!** Re-cleco the doublers back onto the rib and rivet together using the ZINC CHROMATE method specified earlier. You can then reinstall the rivets in between the hinge bracket holes first, then reinstall the hinge bracket. You can now finish by riveting the skin back to the rib. Do not rivet any of this together if you have a cracked spar! Please contact us when you get to this stage for further instructions. Repeat ALL steps for other wing!
